THAMES RIVER BASIN
GRISWOLD, CONNECTICUT

HOPEVILLE POND DAM
CT. 00438

PHASE 1 INSPECTION REPORT
NATIONAL DAM INSPECTION PROGRAM

AUGUST, 1980

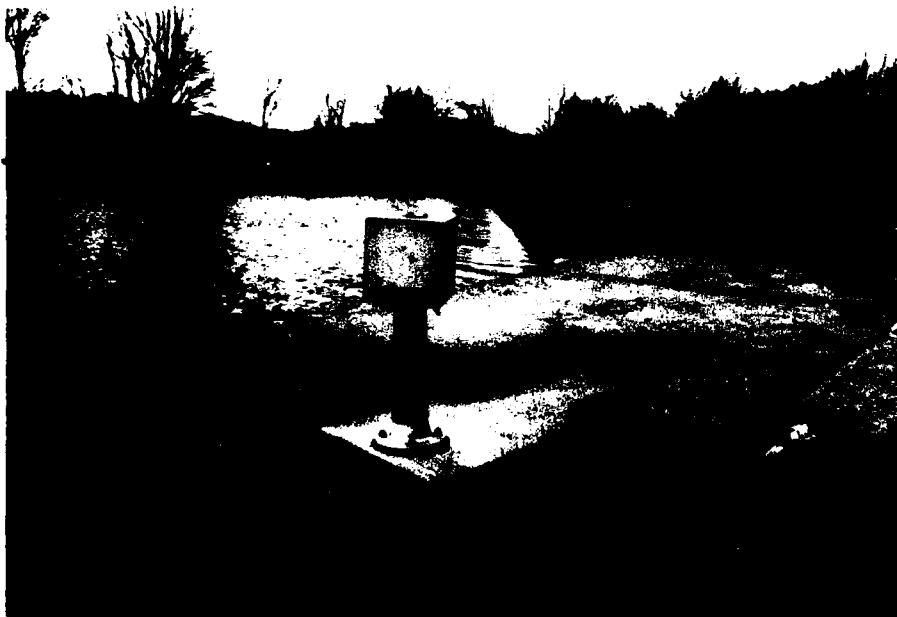
PHOTO C-10 Right outlet works manually controlled sluice gate with lockable hood.

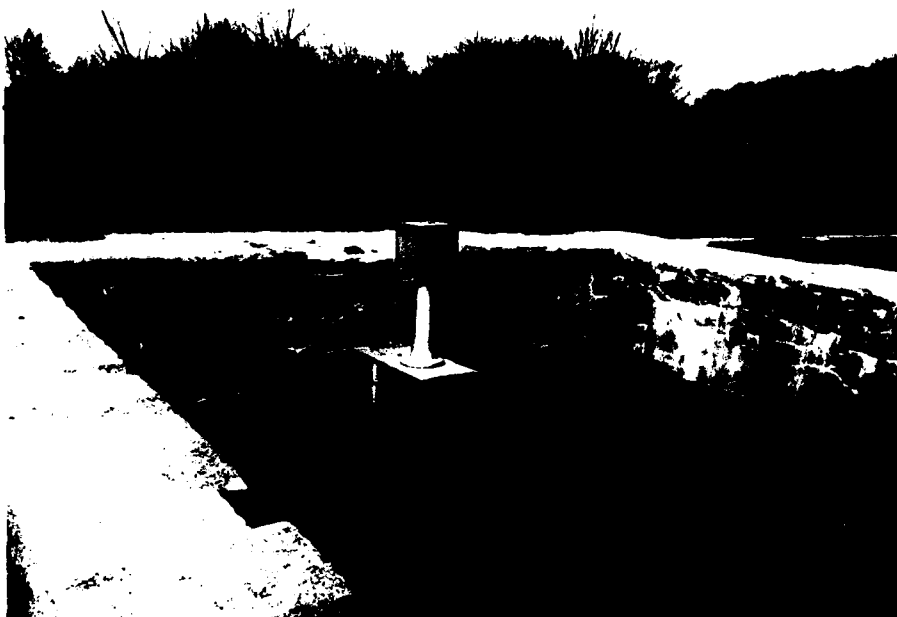
PHOTO C-11 Left outlet works manually controlled sluice gate with lockable hood.

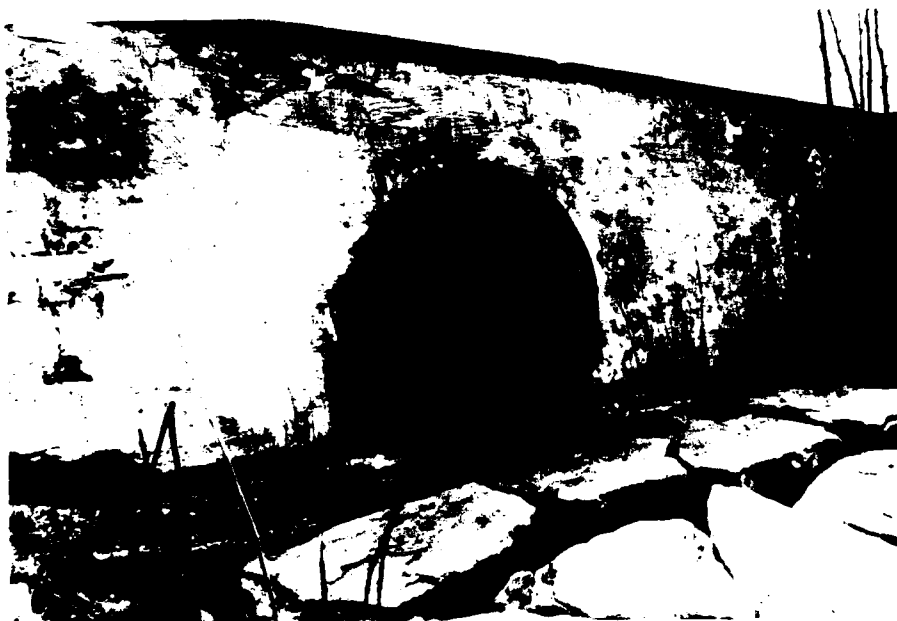
PHOTO C-12 Left outlet works conduit and stone masonry foundation ruins at downstream toe of dam.

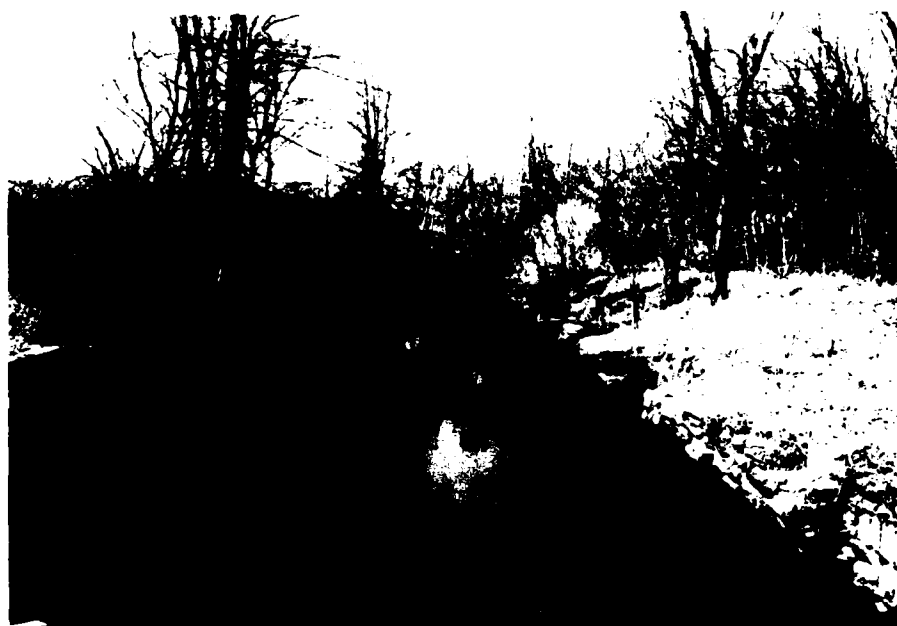
PHOTO C-14 Tailrace looking from invert of 96-inch diameter outlet conduit left dam embankment.
